FULL-SCALE DYNAMIC CRASH TEST  
OF A  
LOCKHEED CONSTELLATION MODEL 1649 AIRCRAFT

TECHNICAL REPORT  
ADS - 38

October 1965

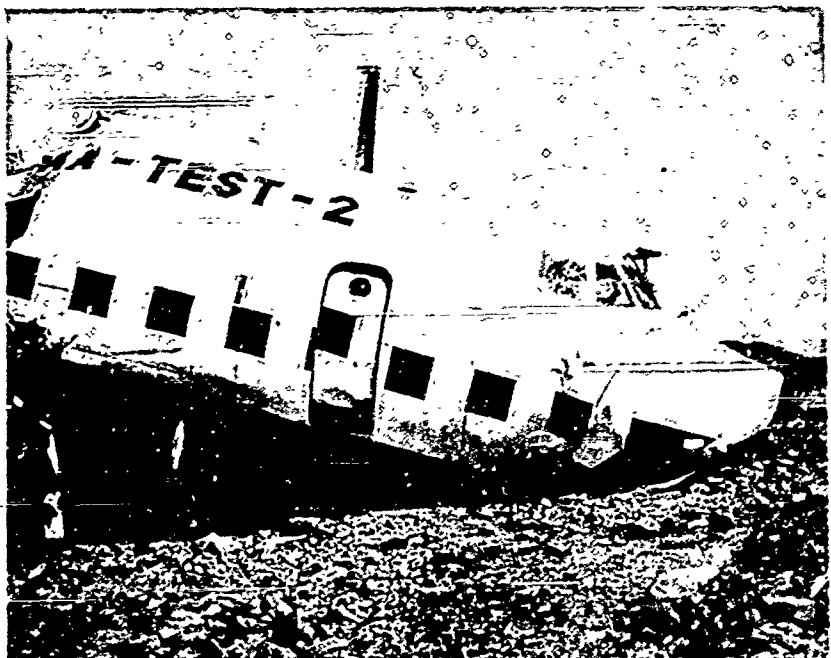
FIG. 29 FORWARD FUSELAGE AND COCKPIT STRUCTURAL  
DEFORMATION, RIGHT SIDE

The extreme forward end of the cockpit, as shown in Figures 29 and 30 was pulled under by the impact and friction against the 20 degree slope causing considerable damage in the vertical space forward of the pilot's and copilot's seats. The floor structure beneath the pilot's and copilot's seats was still intact, but the fuselage beneath this position was crushed so that there was no space left beneath the floor. Aft of the pilot's and copilot's position the cockpit floor was deformed upward and twisted. The floor panel normally located between the engineer's seat floor tracks was knocked out, leaving a large opening. The air conditioning and pressurization control panel sprung free from the fuselage station 260 bulkhead and partially blocked the passageway leading to the side, crew entrance door. The upper cockpit structure was deformed to such an extent that the side, crew entrance door could not be opened (see Figure 31), however, exit from the cockpit was still possible through the main cabin.

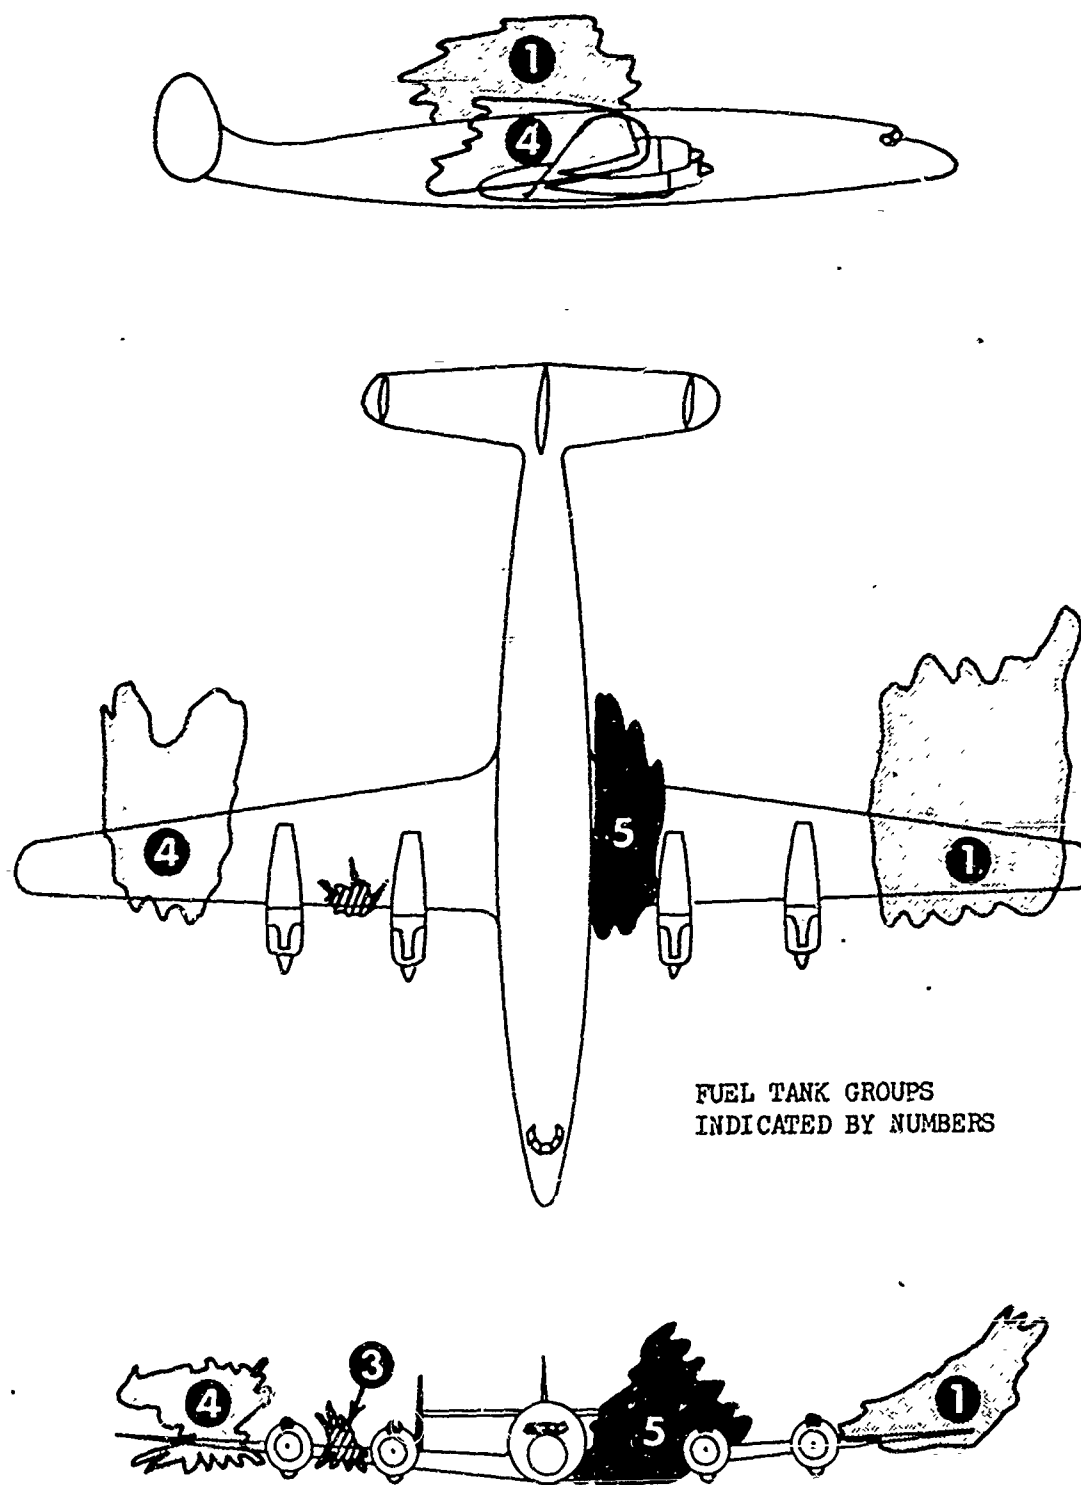
FIG. 40 FUEL SPILLAGE OCCURRING 1.00 SECONDS AFTER  
IMPACT WITH MAIN GEAR BARRIERS

Initial impact and subsequent course of the aircraft through the barriers caused the wings to fail or disintegrate, spilling the simulated fuel. Figures 40, 41, 42, and 43 present a kinematic of the fuel spillage during the crash.

The No. 1 fuel tank was ruptured when the outer portion of the left wing impacted against the earthen barrier. The complete destruction of the tank caused the entire volume of simulated fuel to be released in a heavy mist. As the aircraft contacted and slid forward up the 6 degree slope, the wing was partially separated from the fuselage at the root. This failure opened up the No. 5 fuel tank allowing its simulated fuel to be completely expelled in a mist cloud by the time the aircraft came to rest on the 20 degree slope. Traces of the simulated fuel were found 15 feet ahead of the aircraft.

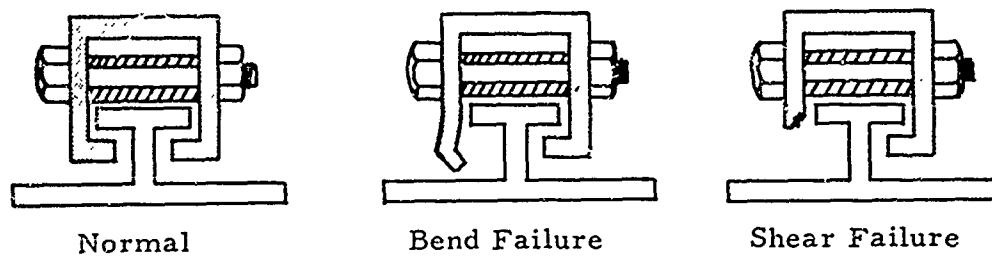
FIG. 51 SEAT TRACK ATTACHMENT FAILURES

The third crew seat was torn free of the floor tracks due to failure of the attachment grips as illustrated in Figure 51. This allowed the seat and its occupant to travel forward and to the left until they contacted the bulkhead at fuselage station 260. The seat and dummy came to rest blocking the cockpit door as shown in Figure 59. The dummy was well restrained in the seat by the diagonal shoulder harness and lap belt throughout the crash. The back of the seat was bent forward, approximately 5 degrees. The complete failure of the attachment of this seat to the floor was attributed in part to a high localized load caused by the nose gear structure which was embedded under the fuselage just beneath the seat. Figures 60 and 61 show the seat tracks and the track grips.

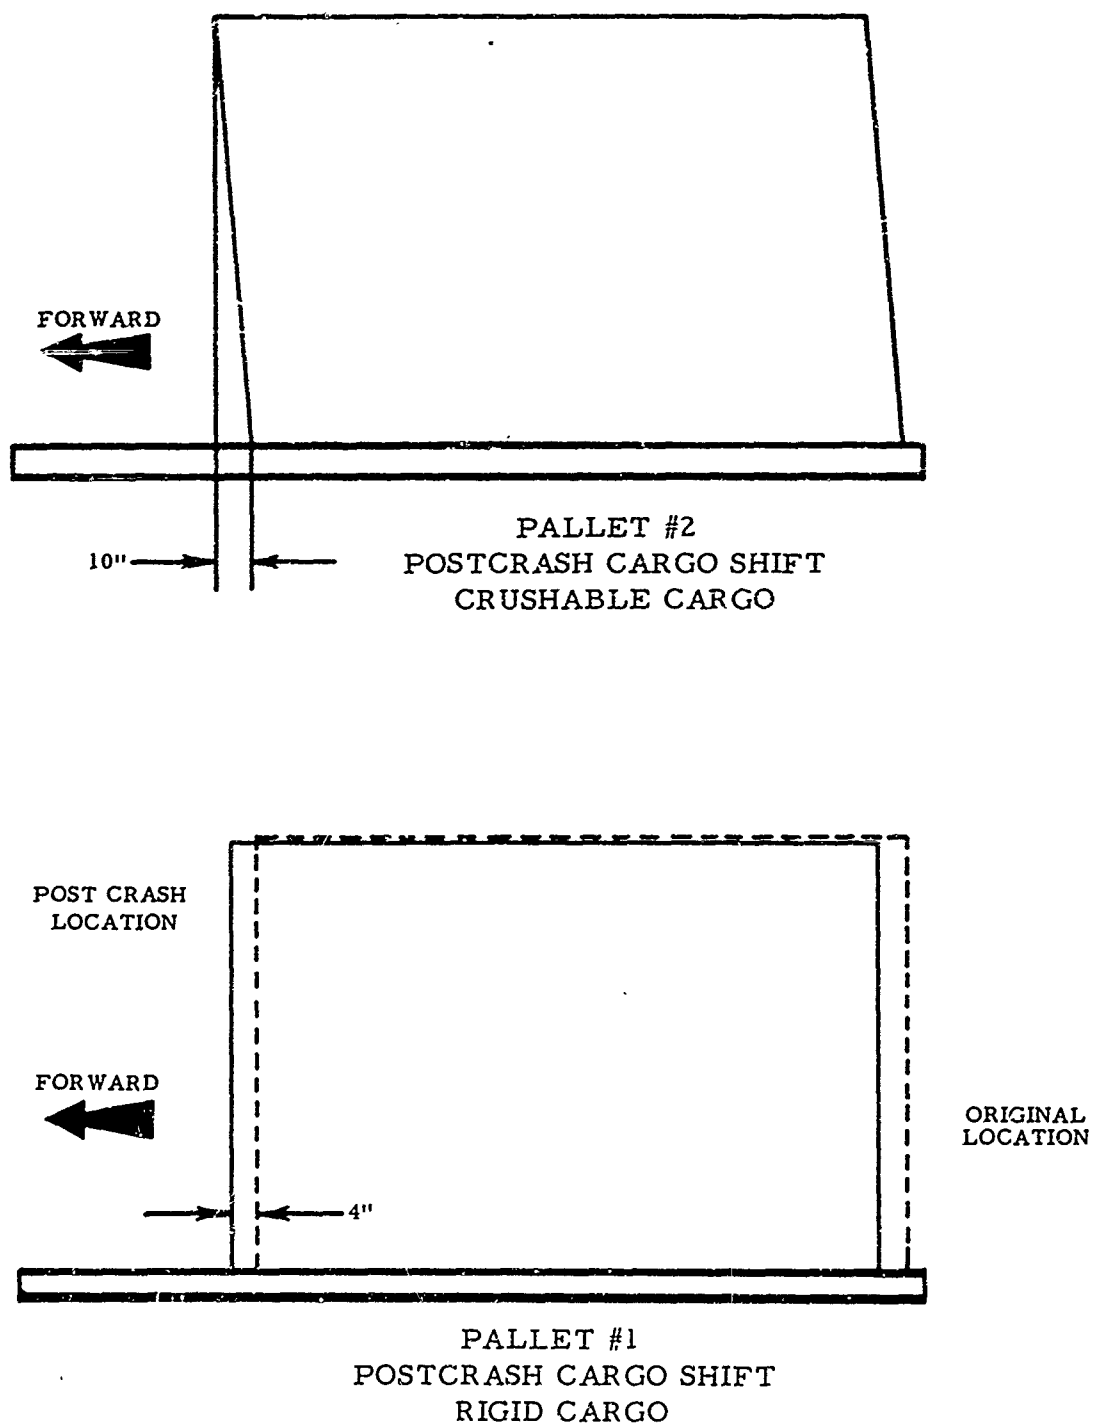
FIG. 78 FORWARD MOVEMENT EXPERIENCED IN CARGO LOADS

During the crash, neither pallet nor cargo separated from its original tiedown, however, both of the longitudinal restraint installations of the cargo pallets deformed approximately 2 inches forward as shown in Figure 77. The flexible nets survived the crash with no load ring deformation, and no failures occurred in either of the cargo tiedown systems. The rigid cargo stack slid forward on the pallet approximately 4 inches while the crushable cargo remained in place and programmed forward ten inches. An illustration of the cargo action is shown in Figure 78.
